Number	L.1
Section	Brakes
Sheet	1 (of 2)
Date	January, 1960

DISC BRAKE MASTER CYLINDER RECONDITIONING

Models affected

All cars fitted with disc brakes

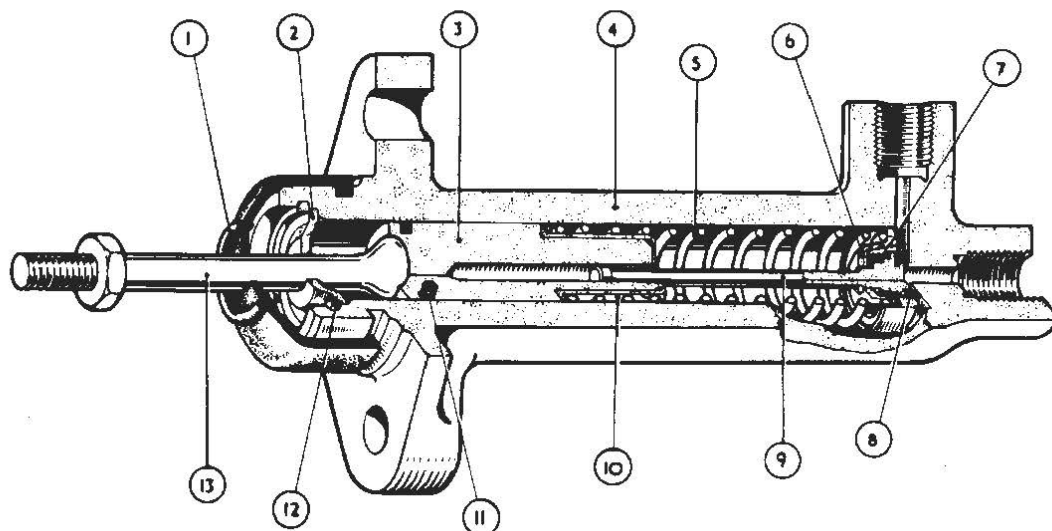
FIG. 1.

When reconditioning a brake master cylinder of the type shown in Fig.1. attached, the following procedure should be adopted.

- (1) Remove the dust excluder from the head of the master cylinder.
- (2) Remove the circlip (using circlip type pliers if available, alternatively, round nose pliers may be used). This will release the push rod complete with dished washer.
- (3) Withdraw the piston and valve assembly complete with springs and supports.
- (4) Discard the piston and valve assembly (items 3, 5, 6, 7, 8, 9, 10 and 11 on Fig.1) and the circlip (12).

- (5) Wash cylinder, push rod, rubber dust excluder in methylated spirit or clean brake fluid. Check that cylinder bore is in good condition and that dust excluder and dished washer are undamaged.
- (6) As the piston and valve assembly are not anchored together, ensure during fitting that the piston end of the valve stem locates in the piston bore. (See Fig.2.)
- (7) Lubricate the cylinder bore with brake fluid; insert the piston and valve assembly until the piston fitting sleeve engages in the mouth of the cylinder. Push the piston firmly through the fitting sleeve and remove the sleeve when the piston assembly is fully home in the cylinder bore.

- (8) Position the push rod and depress the piston sufficiently to allow the dished washer to seat on the shoulder at the head of the cylinder. Fit the new circlip and check that it fully engages the groove.
- (9) Fill the dust excluder with clean Wakefield Rubber Grease H.95/59. (Tube in kit).
- (10) Reseat the dust excluder around the head of the master cylinder.
- (11) Remove the existing identification tab and fit new tab supplied.

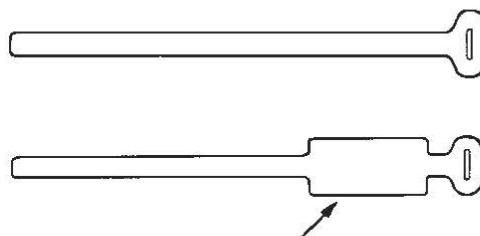
FIG. 3

The identification tab fitted to these types of master cylinders and the tab included in the reconditioning kit 8250 have a widened portion as indicated by the arrow in Fig.3.

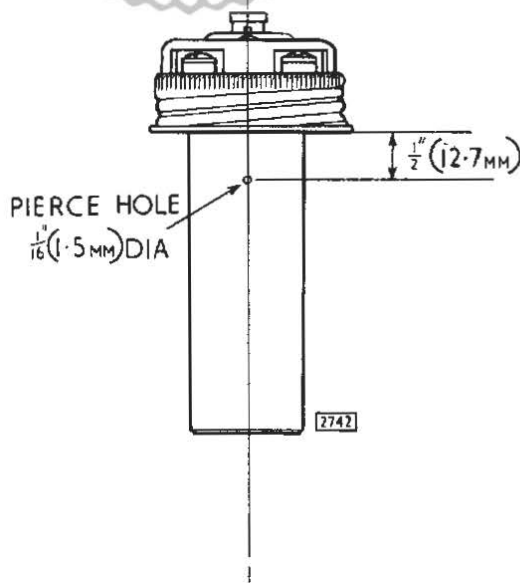
This has been found to be due to a pressure difference between the inside and outside of the float container.

The remedy is to pierce (do NOT drill) a $\frac{1}{16}$ " (1.5mm) hole through the float container in the position shown in the illustration.
